# Case Study: Return of the 'Bottomless Pool' in Yosemite Creek, North Katoomba, Blue Mountains

Blue Mountains City Council

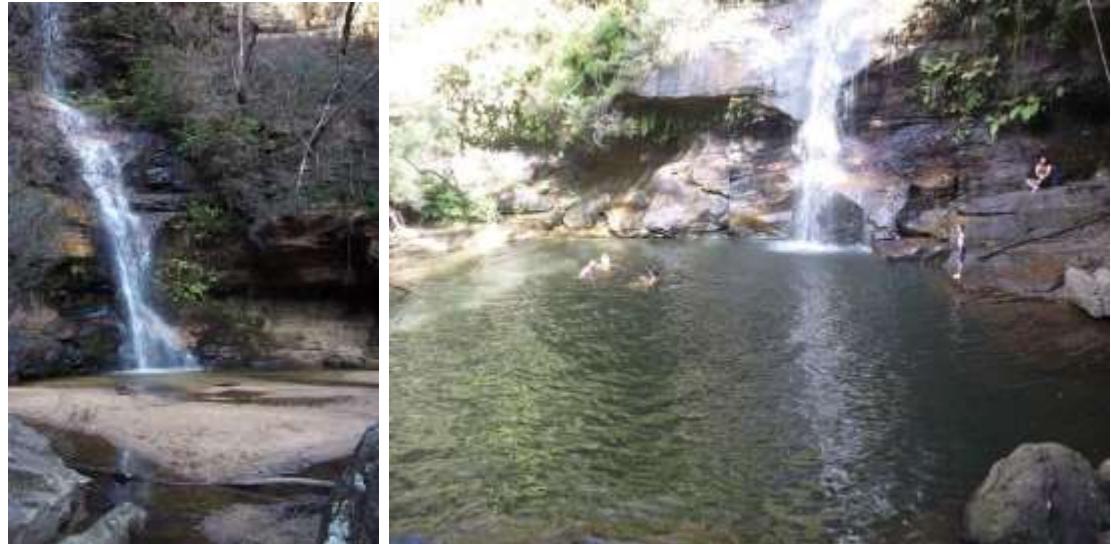
*Photo: 'Bottomless Pool' at the base of Minnehaha Fall, filled with sediment in 2014 (left) and after 2016 (right).*

- 
- Bush Foods Garden established by local Aboriginal community;
  - The 'bottomless' pool at the base of Minnehaha Falls has returned, measuring 25 metres in depth and fast becoming one of the most popular wild swimming holes in the Blue Mountains and NSW.
